MECHANICSVILLE DAM

CT 00182

PHASE I INSPECTION REPORT  
NATIONAL DAM INSPECTION PROGRAM

84 07 24 114  
SEPTEMBER, 1979

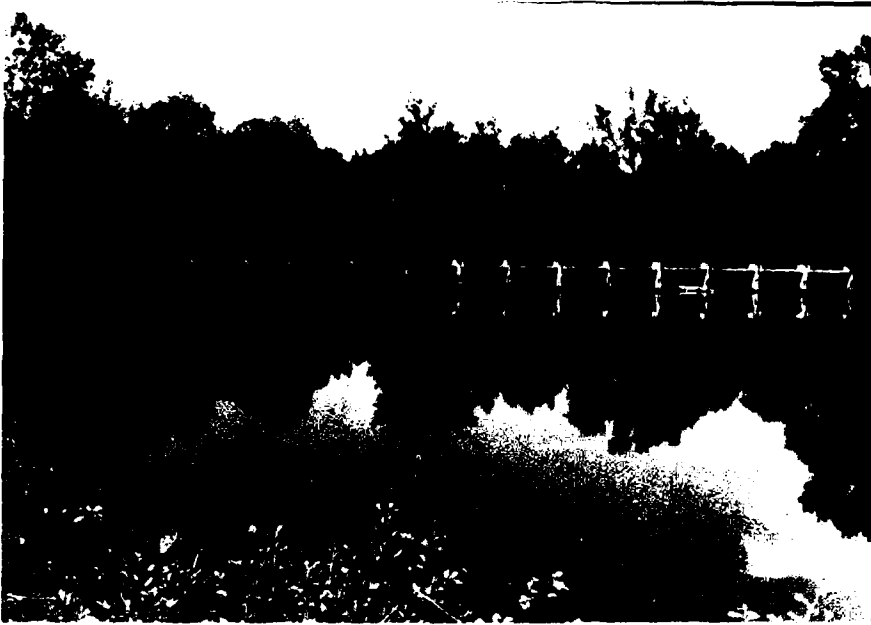
1. Overflow section and bridge from upstream.

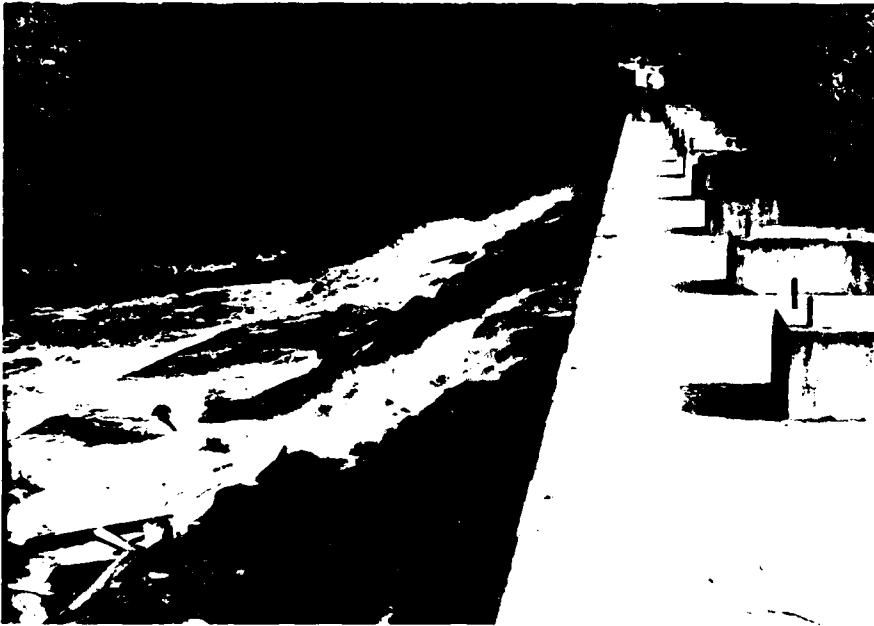
(1) Spillway. The overflow section is comprised of a laid-up stone gravity structure capped with reinforced concrete at its crest and spanned by a reinforced concrete bridge (Appendix C, Photo Nos. 3 & 4). Concrete piers support the bridge and form 16 spillway bays of 11 ft. 6 in., giving the dam an effective hydraulic width of 184 ft. While the massive stone stepped structure and concrete cap were sound and stable, the concrete piers supporting the bridge were in poor condition; spalling has taken place and much of the reinforcing steel is visible. The crest of the spillway and the downstream stone stepped section were covered by debris and remnants of the old spillway bay gates and their control mechanisms. Examination of both banks of the river downstream of the spillway for some distance revealed no evidence of seepage. The masonry at both abutments has become invaded by mature trees which are visibly disrupting the integrity of the walls. On the downstream side of the overflow section at both abutments, shaped concrete and masonry flumes guide the flows to mid channel. At the left abutment the flume's concrete veneer over rubble core has been stripped away. At mid-dam the configuration of the stone is stepped, assisting energy dissipation.

3. Spillway bridge with remains of gate controls.

- (1) Make a thorough study of the hydrology of the drainage basin, including an assessment of the attenuating effects of Lake Webster. Review the spillway adequacy in relation to the potential overtopping of the abutment walls and the dike.
- (2) Determine whether the spillway bridge should be repaired or removed.

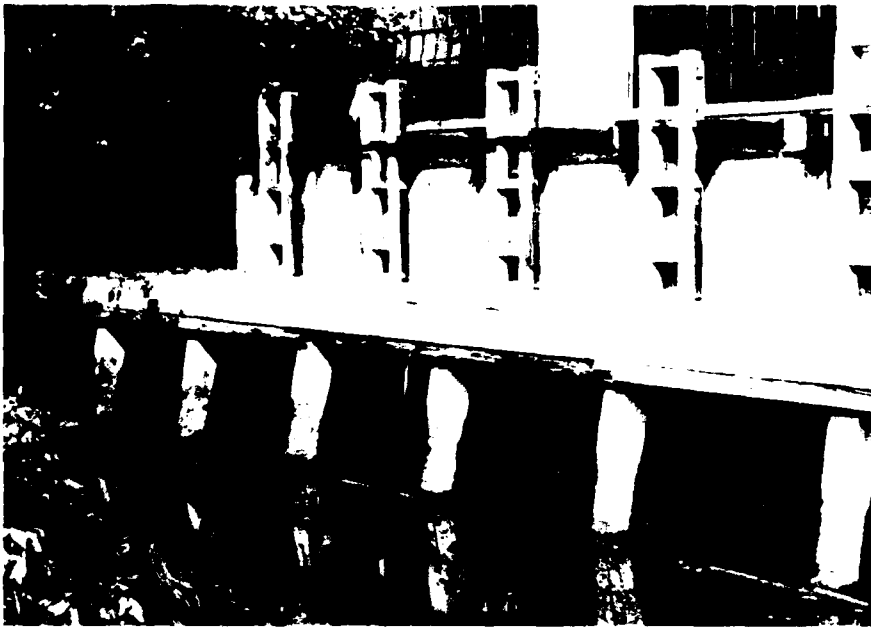
To the left of the stone wall is the abandoned power house and forebay with 6 intake gates into the old turbine room of the structure (Appendix C, Photo No. 5). The gates were in a closed or nearly closed position, but water was leaking through the structure (Appendix C, Photo No. 6). From the floor of the power house, inspection of the turbine areas was attempted through an uncovered access hole, but the water surface was within 6 ft. of the floor obscuring all detail. There is a bypass flume to the left of the intake gates in the forebay. Water appeared to be leaking between the forebay and the flume as the aperture through the wall was at least 1 ft. above the level of the water (Appendix C, Photo Nos. 7 & 8). The power house structure was in a dilapidated condition.

5. Five of 6 intake gates to power house.
